DEPARTMENT OF TRANSPORTATION

Contract #: 04-0120F4Cty: SF/ALA Rte: 80 PM: 13.2/13.9File #: 69.28**WELDING INSPECTION REPORT****Resident Engineer:**Pursell, Gary**Address:** 333 Burma Road**City:** Oakland, CA 94607**Report No:** WIR-010660**Date Inspected:** 01-Dec-2009**Project Name:** SAS Superstructure**OSM Arrival Time:** 645**Prime Contractor:** American Bridge/Fluor Enterprises, a JV**OSM Departure Time:** 1845**Contractor:** Zhenhua Port Machinery Company, Ltd (ZPMC), Changxing Island **Location:** Shanghai, China

Bay 11, South Tower, Struts.

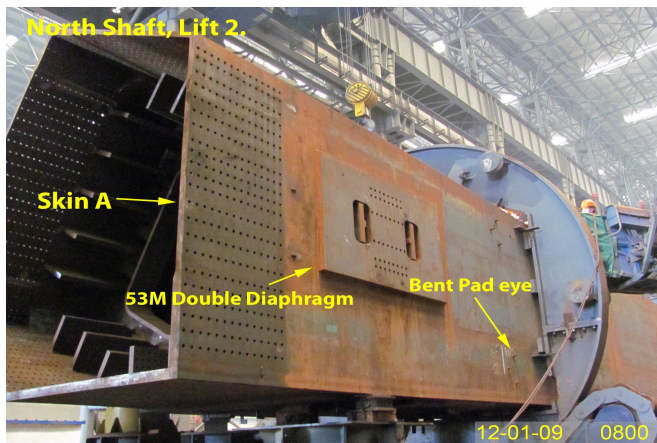
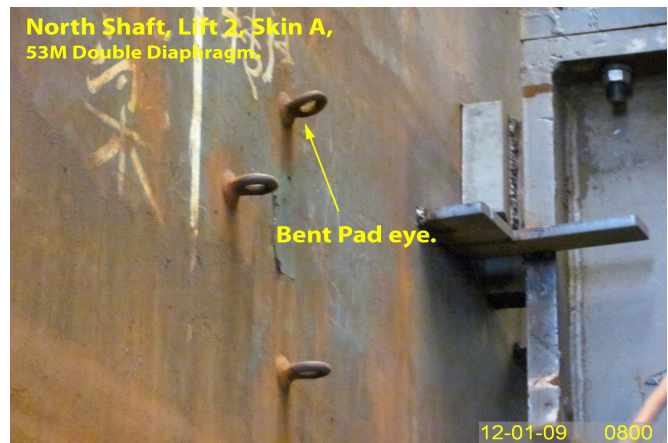
Bay 10, North Tower, Lift 2, Skin A, Pad Eyes.

During Random in-process inspection this This QA inspector observed one of the pad eye bent on North Tower, Lift 2, Skin A near A/E Corner 53M Double Diaphragm(Bottom). All required inspection is done on these pad eyes.
